**SERVICE BULLETIN #7 JAN 2019**

**TAG, Ball seems to keep playing after initially lodging in the right side captive rail (up the T2 ramp)**

**Application: All machines.**

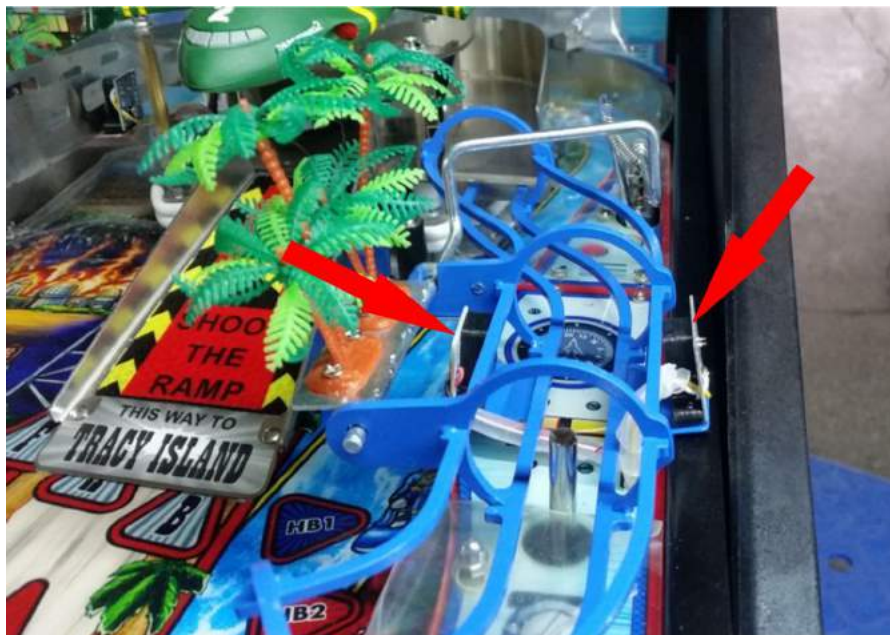
**(1) Identify the IR transmitter and IR receiver boards mounted on the right rail near the ‘up post’.**

**(2) You can see in the picture above the IR beam is not aligned, the TX and RX boards are not pointing at each other.**

**(3) This can cause the machine to ‘think’ there is a ball sitting in the captive position and so it will eject and auto-launch a new ball whenever a ball drains. This process will repeat and it will**

**appear as if the ball can be kept in play 'forever'. This is a fault situation and is not normal.**

**(4) Bend the mounting metal tabs on both the TX and RX so that they face each other more accurately. They DO NOT need to align perfectly as the parts used have a beam spread of 30°.**

**Take care when bending the metal tabs as they are spot welded to the metal rails and these welds can break if too much force is used to bend the tabs. Also note the outside tab will probably be resting on the RHS metal playfield rail so a compromise might have to be made for its final positioning.**

**Bend only as much as is needed to correct the auto ball launching sequence.**
