SN6

## **Blues Brothers Pinball by Homepin**

Service note six - (five pages)

### **Replace 5 x MOSFETS**

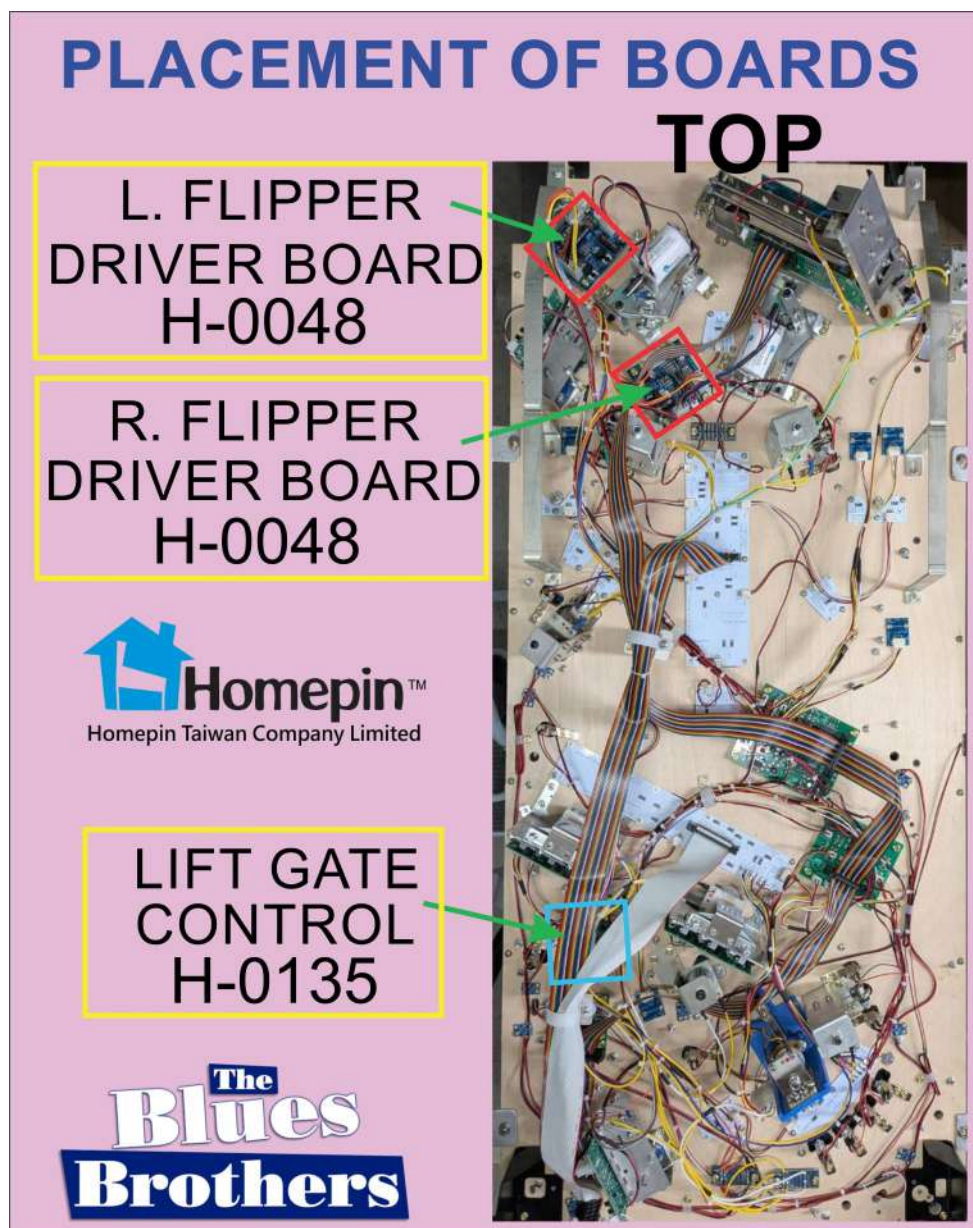
Locate the three boards screwed under the playfield shown in the picture below. They are 2 x H-0048 flipper control and H-0135 lift gate control. Unplug the cables connecting to these boards and remove them from the playfield. Each board is held to the playfield with 4 x gold screws.

Replace the MOSFETS in the flipper control boards with a different type & also replace the lift gate control driver MOSFET. (detailed explanation at the end of this service note for those interested in more details).

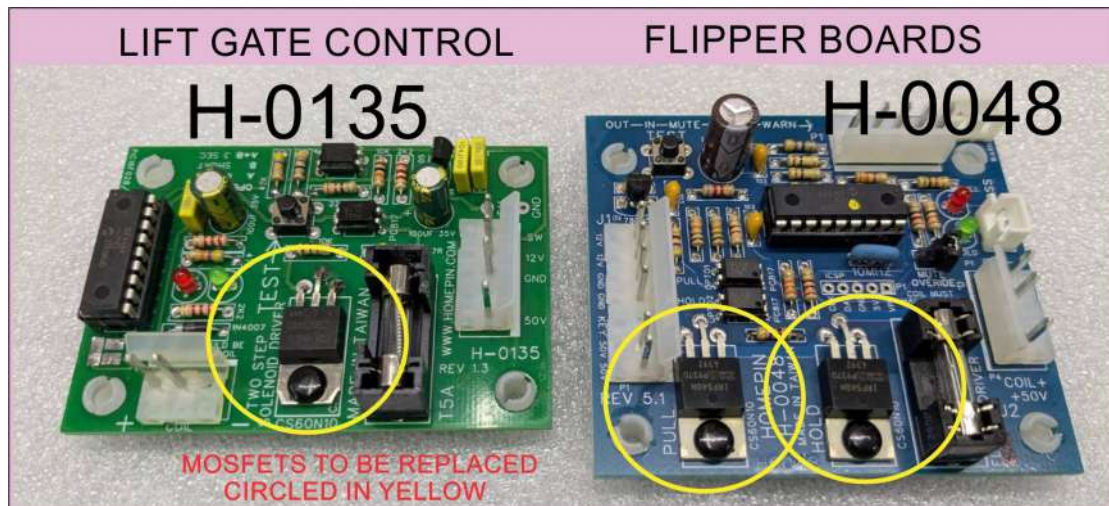
These are the boards you should now have removed from the machine.

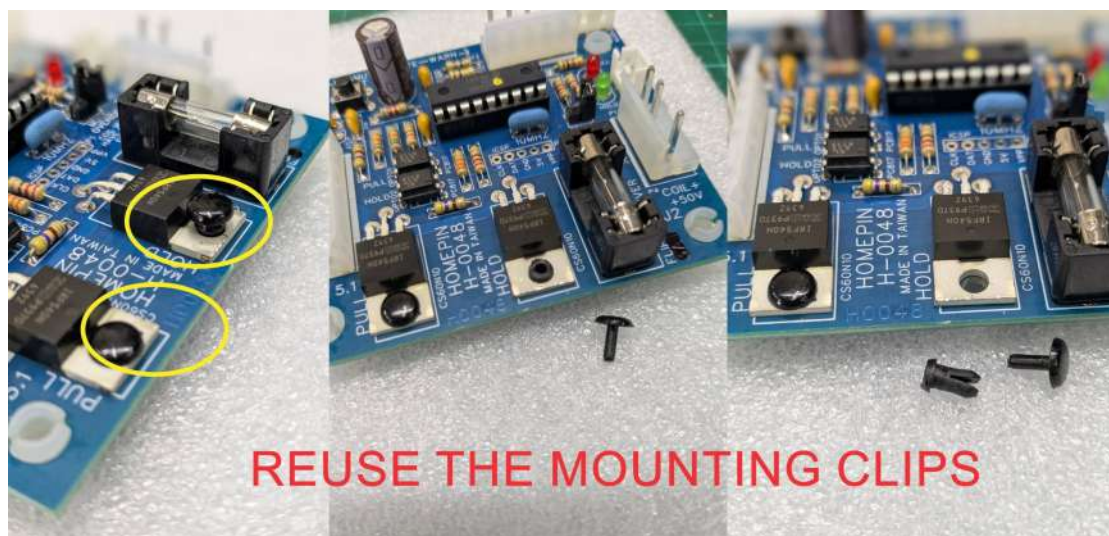
With the boards on a workbench, remove the two piece plastic retaining clips as below.

The easiest way to remove the old parts is simply cut the legs and use a soldering iron and pointy nose pliers to remove each cut leg one-by-one.

**Suitable replacements are IRF540N (note the “F” in the part number – NOT an IR-L-540N).** Please don't buy these from dodgy online vendors such as Amazon, Ali-Baba, eBay etc as they are very likely to be fakes and you will only create more problems than you fix by using these parts.

Fit the replacement MOSFETS and fix them in place with the plastic clip before soldering and trimming the legs.
